# **Resistivity imaging and self-potential applications in groundwater investigations in hard crystalline rocks**

**S.U.P.<sup>1</sup> Jinadasa and R.P. de Silva<sup>2\*</sup>**

**Abstract:** Despite massive river diversion schemes there is a shortage of water in most areas of the dry zone of Sri Lanka. Therefore, prospecting for groundwater in the hard crystalline rocks is a top priority. A geological and geophysical study was therefore carried out to investigate groundwater accumulations in the hard rock terrain in Moneragala, using the resistivity imaging and self-potential techniques. This possibly is the first time that the above technique is used in the country, in prospecting for groundwater.

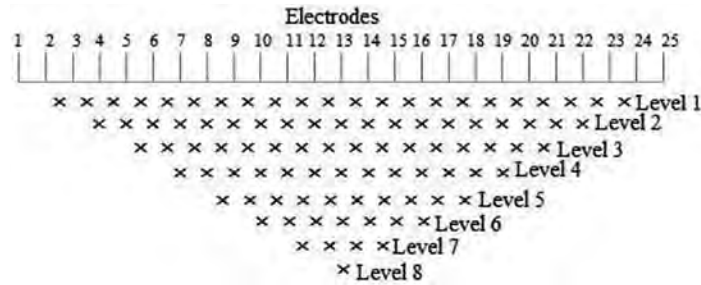
Figure 2: Electrode setup and measurement sequence for building up a pseudosection<sup>9</sup>

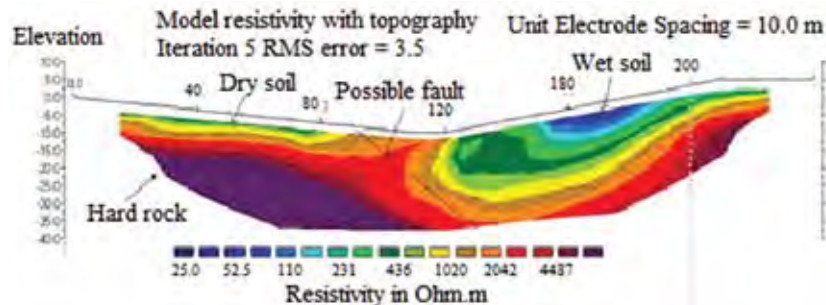
Figures 3 and 4: Resistivity image and SP survey profile respectively for transect  $W_4W_1$

The resistivity image for transect  $W_4W_1$  shown in Figure 3 was conducted across the Mandappan Oya (stream). The results suggest a possible fault structure (Figure 3) as seen in the structural map of the area as well (Figure 1). Rocks with high resistivity were observed at upper left area of the profile (from a distance of 0 m to about 80 m). These high resistivities are shown on the right side of Figure 3 at a depth of more than 40 m which suggests

vertical displacement of the rocks with high resistivity along the fault plane. The low resistivities at the upper right area at a distance of about 180 m in the profile possibly suggest groundwater accumulations.

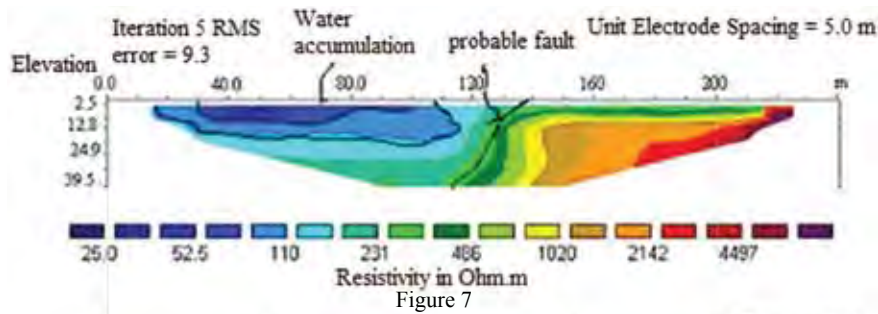
Figure 7

Figures 7 and 8: Resistivity image and SP survey profile respectively for transect  $W_4W_3$

The resistivity imaging profile for transect  $W_4W_3$  indicates a directional fault (Figure 7) below the 13<sup>th</sup> electrode at a distance of about 120 m. A directional fault was identified around the same location in the geological and structural map. Figure 8 (which shows the SP anomalies for transect  $W_4W_3$ ), indicates negative anomalies at the centre of the profile at a distance between 25-120 m thus tallying well with the low resistivity values of the resistivity image. It must be noted that

water accumulations are not indicated near the probable fault, as it is unlikely that water will accumulate near the fault since it is almost a vertical one.

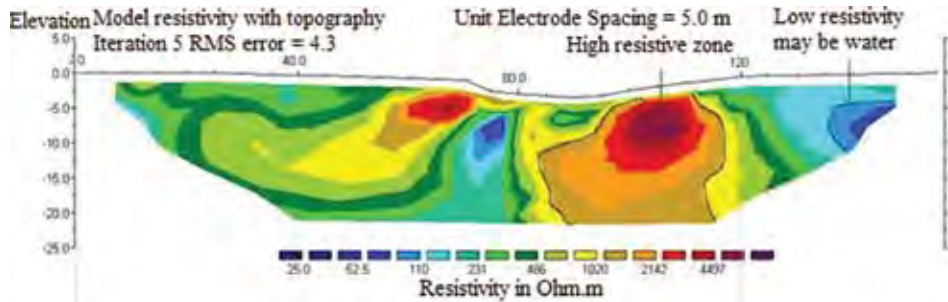
Figure 9

Figures 9 and 10: Resistivity image and SP survey profile respectively for transect T<sub>5</sub>W<sub>1</sub>

Transect  $T_5W_1$  was selected to investigate a structurally fractured zone in the area, as identified by aerial photographs. The resistivity image for the transect (Figure 9) has two high resistivity zones separated by low resistivities. The high resistivity zone on the left side of the profile is restricted to shallow depth, possibly representing a hard rock boulder overlying soils with low resistivity. The high resistivity zone on the right side of the profile at a horizontal distance of about 80 – 120 m stretches deeper, indicating a possible extension of the basement rocks.

The low resistivity zone in Figure 9, sandwiched between two high resistivity zones, possibly indicates the existence of a weak geological structure, which is favourable for the accumulation of groundwater. Two

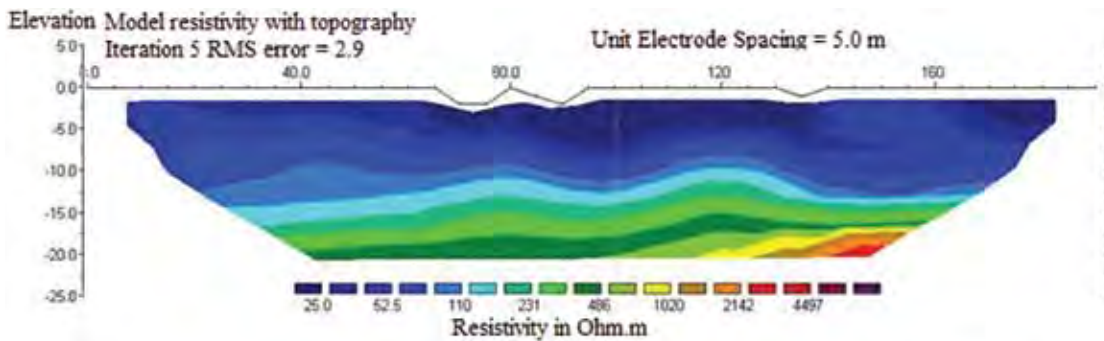
Figure 11

Figures 11 and 12: Resistivity image and SP survey profile respectively for transect T<sub>5</sub>W<sub>2</sub>

There is no evidence for significant geological structures for the transect T<sub>5</sub>W<sub>2</sub>. As such, groundwater in this area is likely to accumulate in the top soil layer and not in deep geological structures. This was evident during field inspection of existing wells in this area where they indicated that the water table was less than one metre from the surface. The negative SP anomalies for most of the profile (Figure 12) correspond well with these results. However, the rather high SP anomaly at a distance of about 125 m does not agree with those of the resistivity survey.

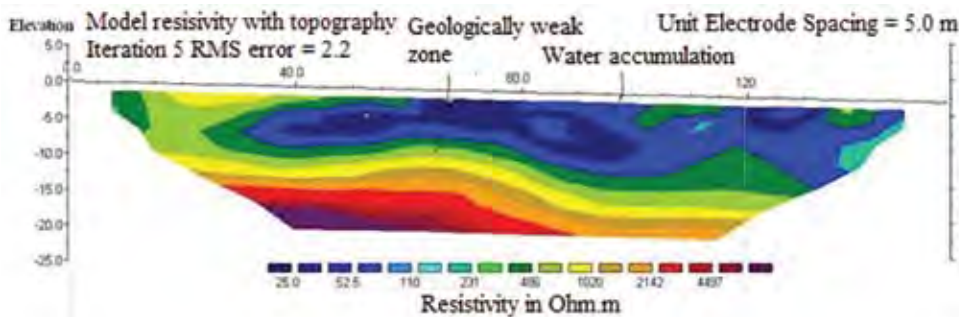
Figure 13

Figures 13 and 14: Resistivity image and SP survey profile respectively for transect S<sub>7</sub>W<sub>1</sub>

The resistivity profile (Figure 13) and SP anomalies (Figure 14) for transect S<sub>7</sub>W<sub>1</sub> indicate areas of low resistivity and negative SP anomalies respectively, thus indicating possible shallow groundwater accumulations. The resistivity image seems to indicate a possible fault at a depth of around 15-20 m, which is not reflected in the SP values.

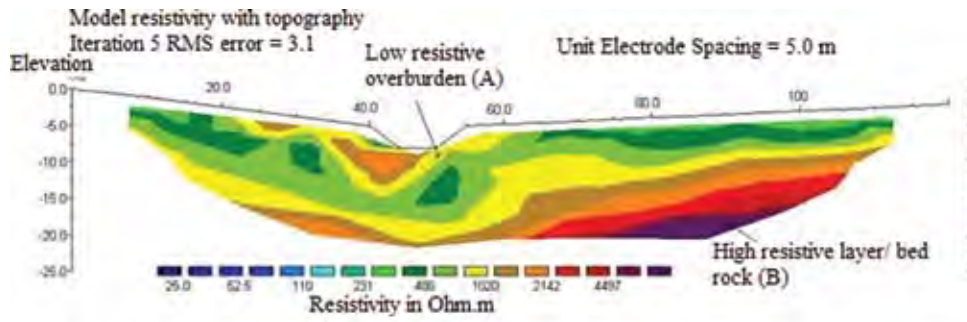
Figure 15

Figures 15 and 16: Resistivity image and SP survey profile respectively for transect S<sub>7</sub>W<sub>2</sub>

Figures 15 & 16 show the resistivity image and SP anomalies for transect S<sub>7</sub>W<sub>2</sub> respectively. As can be seen no significant geological structures are indicated on the resistivity image indicating the unlikely occurrence of structures for groundwater accumulations, which are also

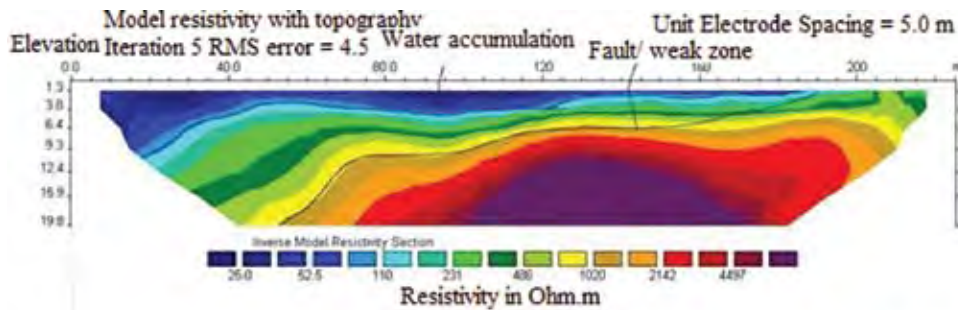
Figure 17

Figures 17 and 18: Resistivity image and SP survey profile respectively for transect S<sub>7</sub>W<sub>4</sub>

Figures 17 and 18 also show good correlation of results obtained by the two methods for transect S<sub>7</sub>W<sub>4</sub> as the low resistivity areas in the resistivity images overlap well with the areas of negative SP anomalies (indicated by P and Q in Figure 18), indicating possible groundwater accumulations. A fault or a weak zone can also be identified from the resistivity image.
